RPV311

Product Advisory

Document No.: F21-0102

Title: RPV311 Flash Player Plugin

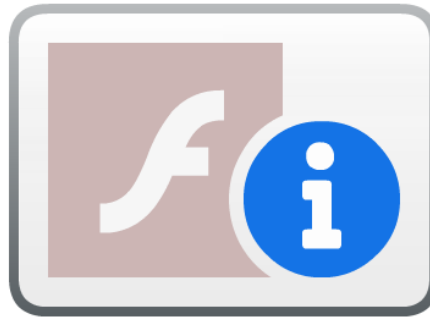
When accessing the RPV311 using a web browser, functions related to web HMI, web configuration, and offline configuration cause error messages to be generated. A typical screenshot such as that shown results.

Figure 1 - Example of Flash Player not configured. Access to RPV311 web interface blocked.

The root cause analysis indicates that this issue is due to a security mechanism implemented in the latest Flash Player that after 12th January 2021 started to block access to all paths that are not allowed under a specific configuration file. This requires a security whitelisting procedure to be undertaken.

For all customers, the recommendation is to implement the procedure titled “How to use Reason RPV311 Web Interface after Flash Player end-of-life,” which outlines the steps to enable the necessary paths to unblock the web interface access to your devices and ConfTool software. You can find the procedure here:
