# Kelman Transfix DGA monitor detects problem with windfarm key inter-tie transformer

# **Success Story**

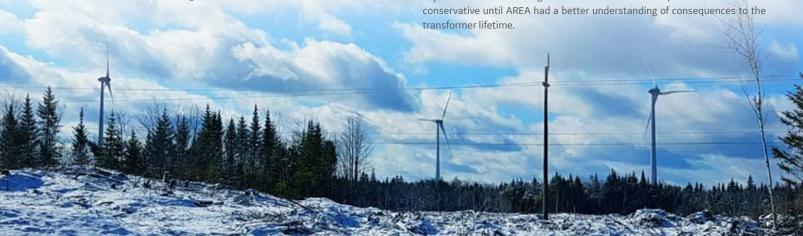
AREA became suspicious when no curtailment took place over the first twelve months of operations at the full 23.5MW. However, lab tests indicated acceptable dissolved gas analyses at the time of sample extractions. Only when the Kelman Transfix generated an IEEE stage-2 CO<sub>2</sub> (carbon dioxide) alarm did AREA's technical consultants investigate the CO<sub>2</sub> trend data from the on-line monitor. The IEEE stage-3 condition was in fact reached soon after!

AREA's self-performed analyses using the facility output and Transfix data suggested that the transformer cooling fans should switch-on earlier to maintain a lower oil temperature. AREA also determined that the oil and winding temperature probes were poorly designed and subsequently replaced them with an ambient temperature probe. The final step was to adjust the "curtailment algorithm" to use ambient temperature and be more conservative until AREA had a better understanding of consequences to the

Since engagement with GE, the CO2 concentrations have decreased and most importantly the CO<sub>2</sub>/CO ratio has stabilized. GE and AREA are further collaborating to determine the optimal parameters to be used for the "curtailment algorithm".
