IS 2632GB
Page 1 /10

HIGH CURRENT BUSHINGS SERIES PTFR

STORAGE, OPERATING AND MAINTENANCE INSTRUCTIONS

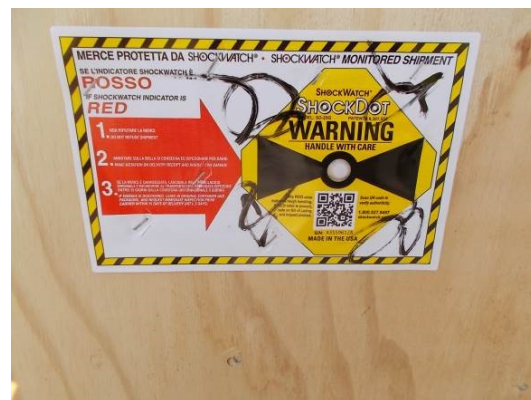
Fig. 4

- Check the external surfaces of the packing cases:
 - No sign of damage must be found;
 - The shockwatch indicator, placed in the external part of each packing case (fig. 4), must be white.

- If the shockwatch indicator is red don't refuse shipment, make a notation on delivery receipt and inspect for damage as follows:
 - Open the packing case by removing its cover;
 - Make sure that the anchoring elements are in order and securely fixed;
